CASE SHARING

CRP II CALIBRATION ISSUE ON BS 240

PRESENTED BY HASSINA SALAH
CLINICAL APPLICATION SPECIALIST
IVD CLINICAL DEPARTMENT SERVICE DEVISION

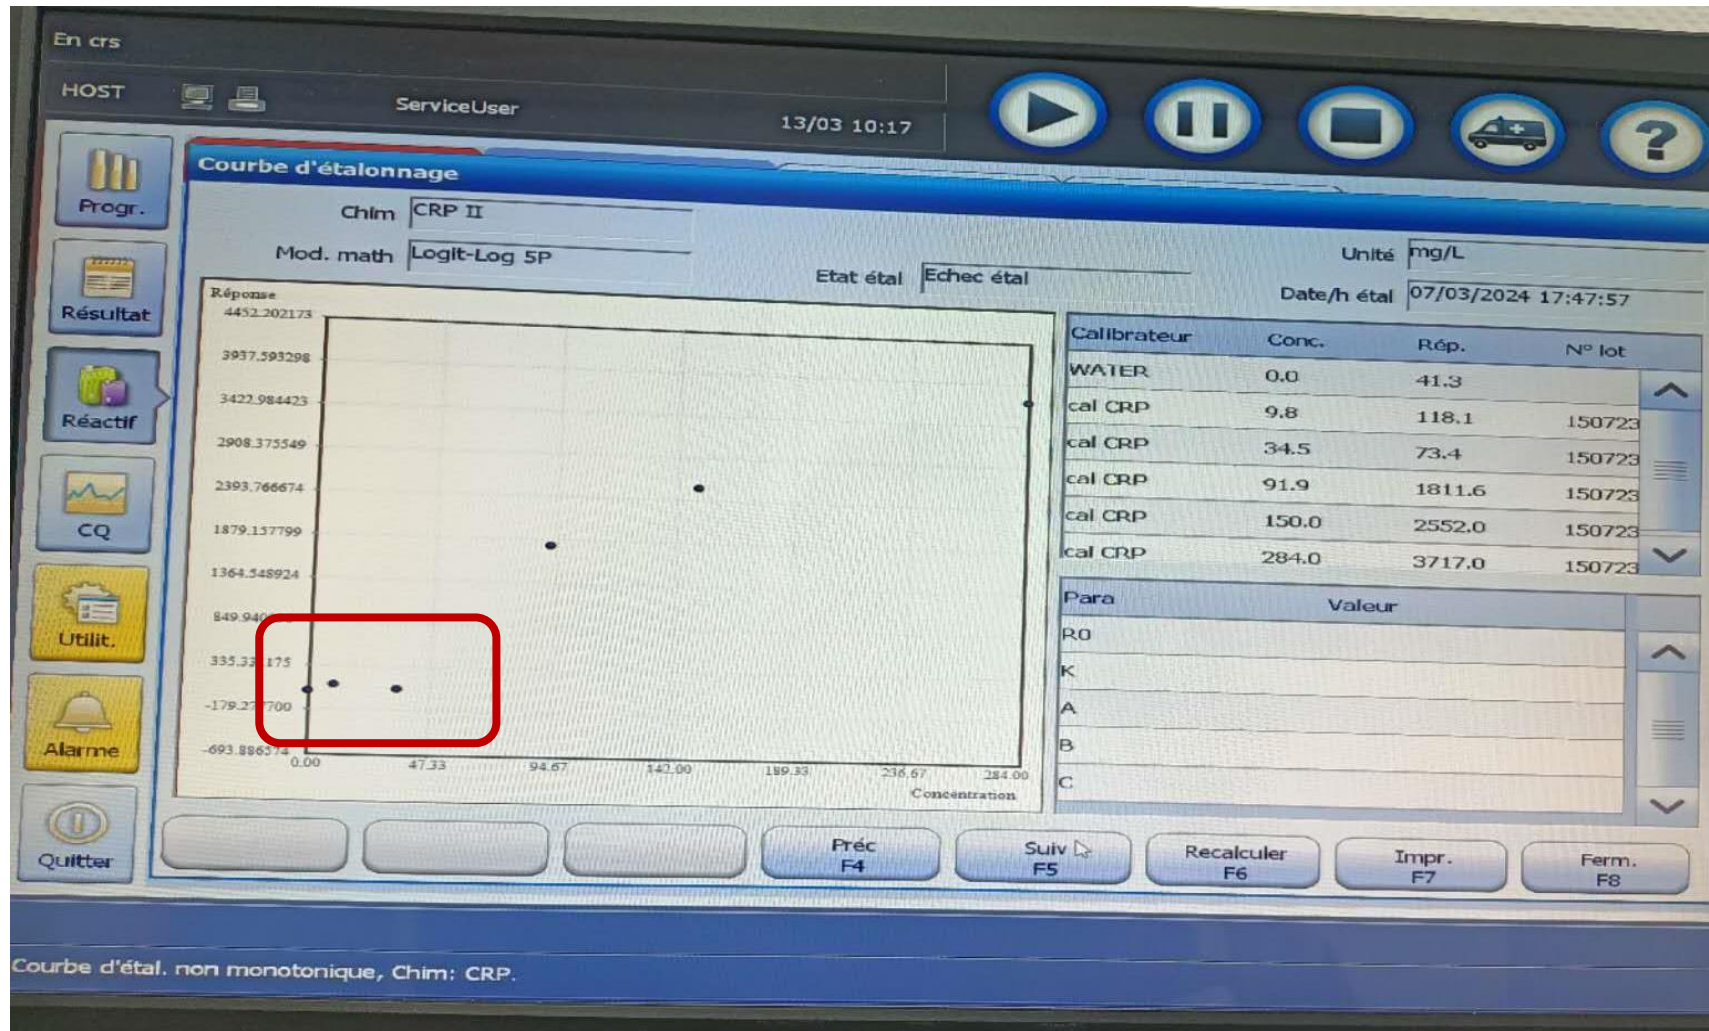
- Where : Private laboratory in Algiers
- Machine model : BS 240 newly installed
- ISSUE : **CRP II calibration failed**
- Flag : **MON**
- Reagent lot number : 148923007
Expiration date : 2024-12-04
- Calibrator lot number : 150723001
Expiration date : 2024-07-31
- QC lot number : no information
- Customer calibrated CRP II 3 times with the same results and flag.

The third level calibration results was lower than the second. It causes **MON** flag.

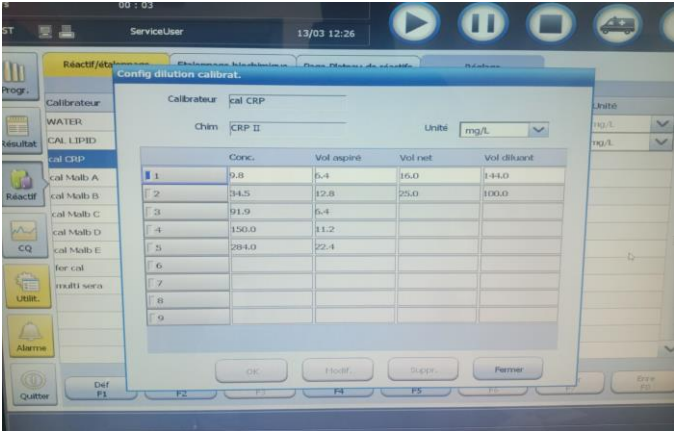
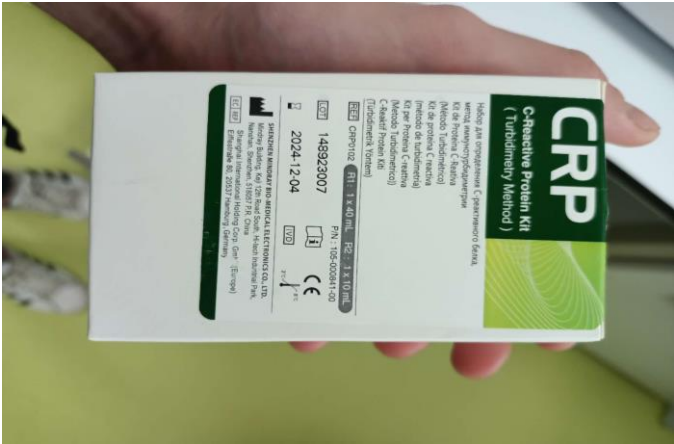
- Parameter settings are normal.
- Calibration settings are normal.
- Calibration dilution settings are normal.

Unlikely to be caused by reagent.

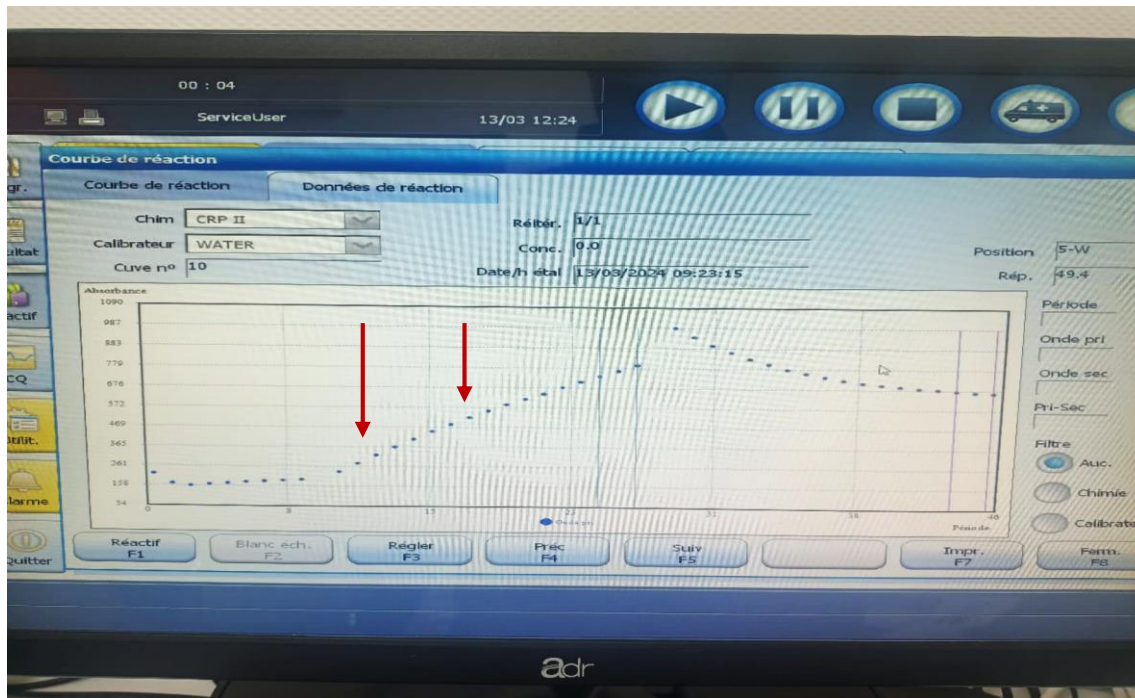
Reaction curve of DI water level

The reaction curve of DI water level was increasing during incubation period, which indicates interference from water. It tells us that the water quality was not good, causing lower results in the calibration levels related to DI water.

DI water was changed and a new calibration was run

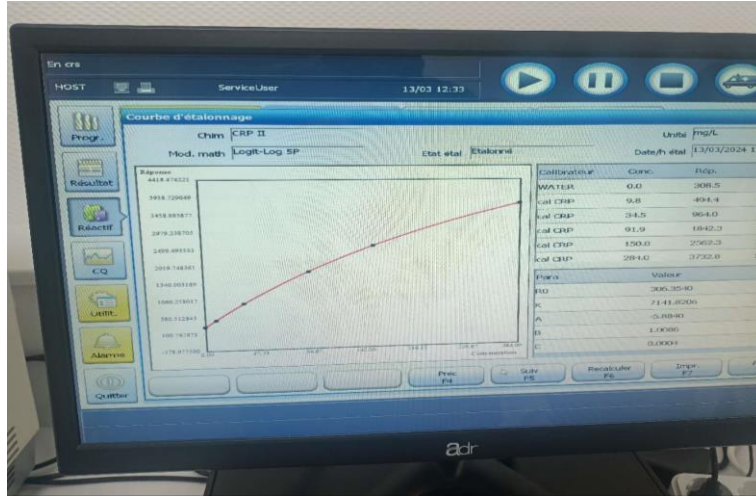
CRP II calibration curve result with good DI water

- The calibration passed
- QC on the target value.

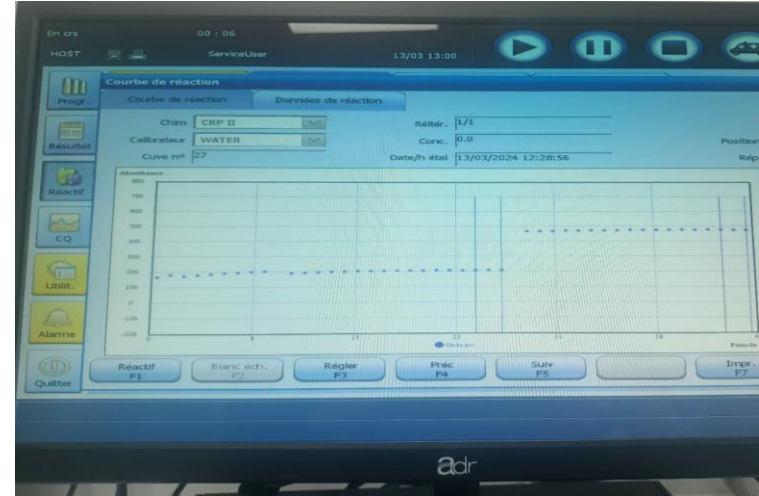
CRP II water reaction curve with the new DI water

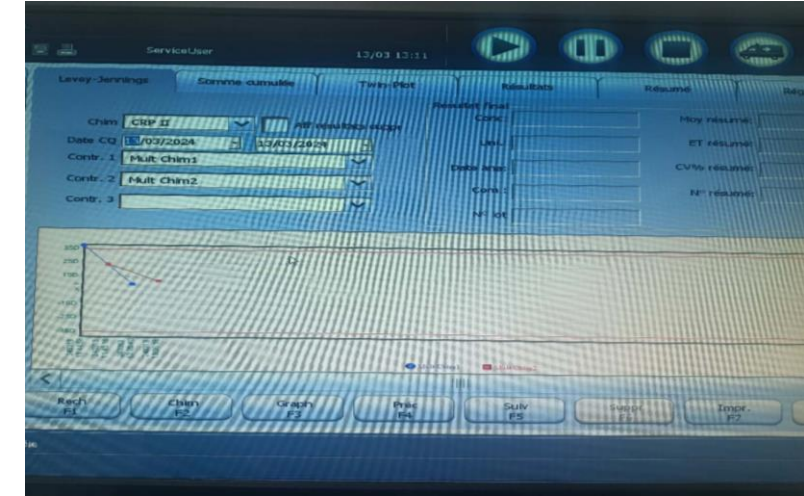
QC level 1 and 2 near to the target value
