MC-80 wrong working area

IVD International Clinical Application Department

2024/9/12

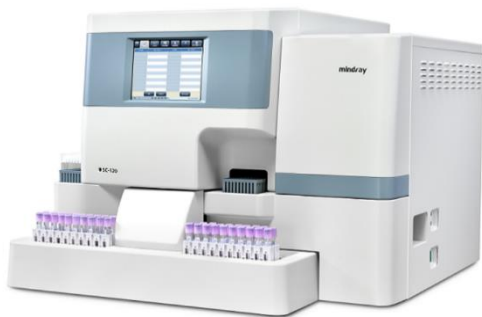
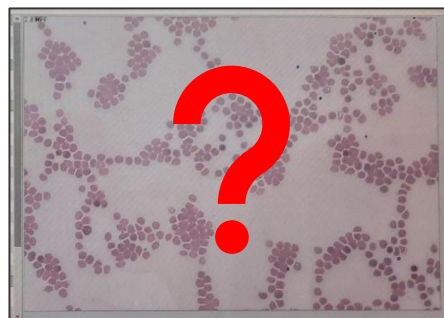
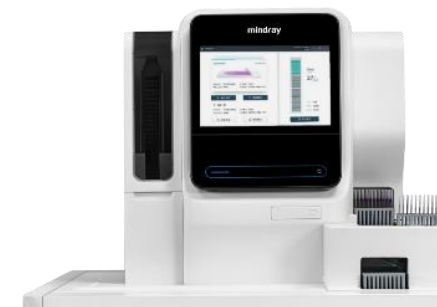
Possible reasons at SC-120 could be related with
incorrect quality of smears:

- smears too short. It leads to wrong working area positioning, the **tail is thin** and cells are sparse and clustered;
- tail of smears **shifted to the left**.

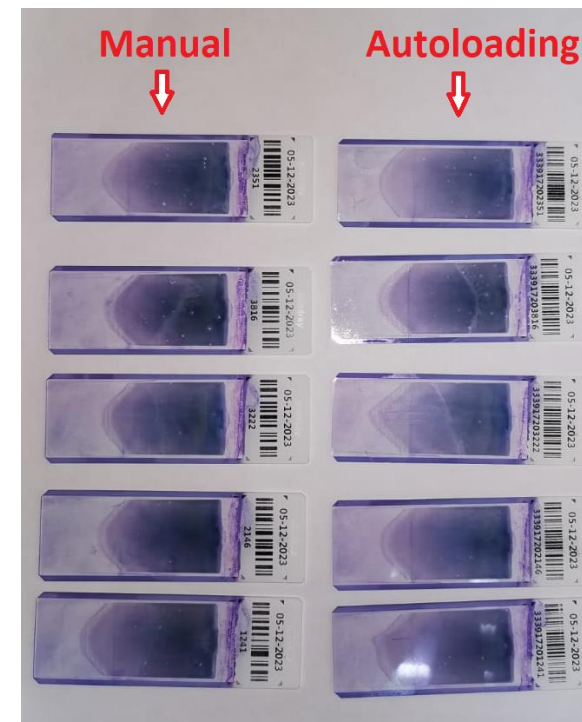
- Was found the **same problem** was at another lab in our region. I contacted with engineer who solved this case to consultation;
- Our reason **wasn't related with SC-120** because all smears was normal and same at manual and autoloading mode

The **shortest** smear was 35 mm

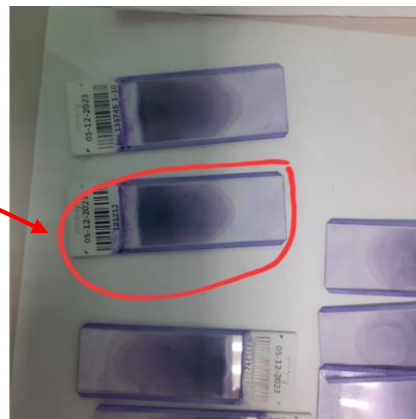
Normal working area

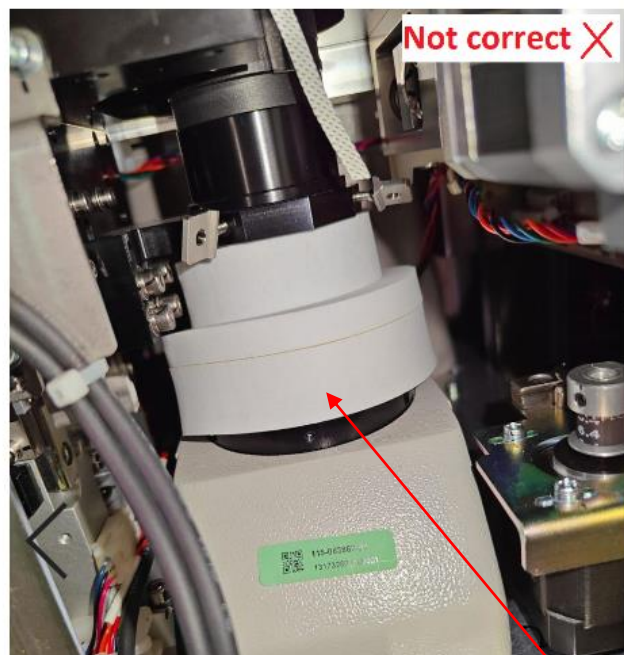
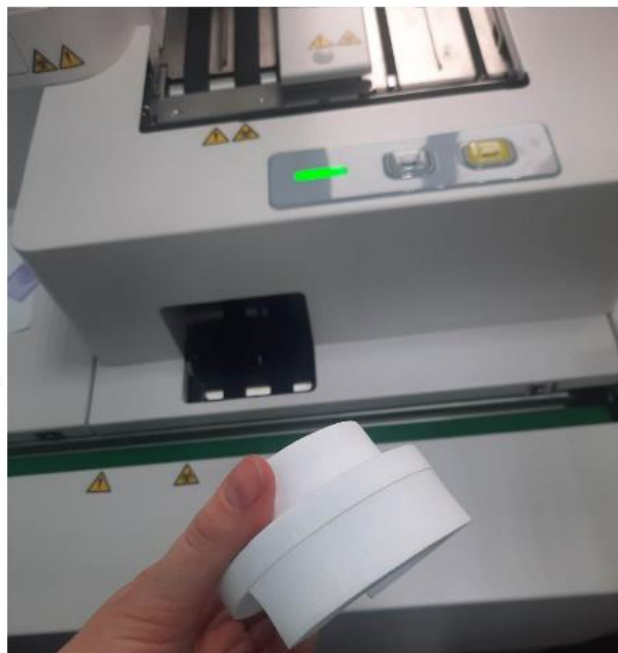
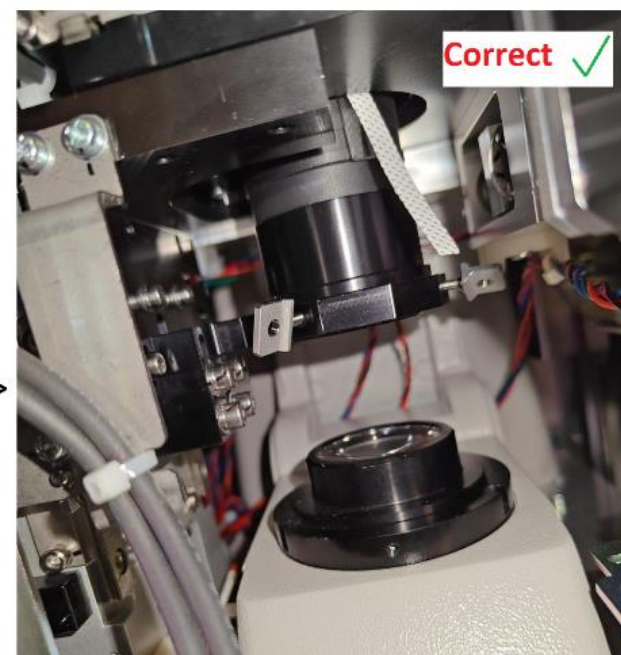
Damper

1. Was found that **damper** from the light source module **wasn't removed at installation**. There wasn't enough light because of this damper. We removed it.

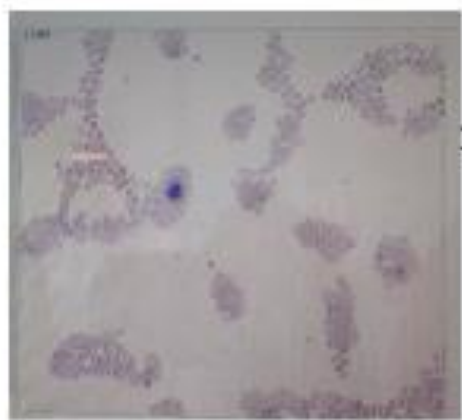
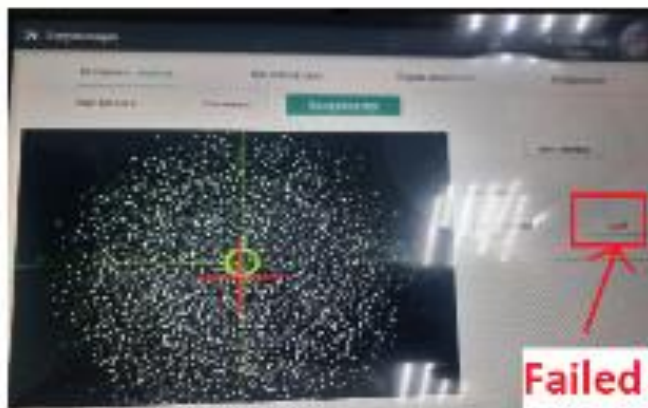
Figure 2 Diagram of Fixture Placing Direction

2. **Scan start position wasn't adjusted correctly.** After communications with engineers was found for correct scan start position adjustment they need special tool - calibration slide but it not included in the set.
