CASE SHARING

CRP II CALIBRATION ISSUE ON BS 240

PRESENTED BY HASSINA SALAH
CLINICAL APPLICATION SPECIALIST
IVD CLINICAL DEPARTMENT SERVICE DEVISION

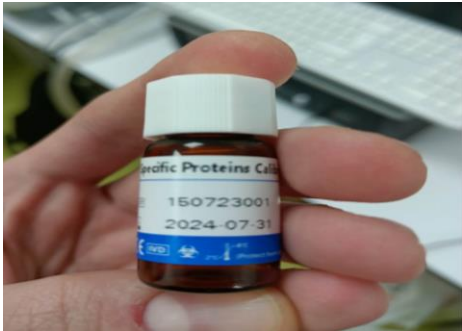
- Calibrator was replaced and with the same result.
- Calibrator volume is enough.

Unlikely to be caused by calibrator or analyzer.
