MC-80 wrong working area

IVD International Clinical Application Department

2024/9/12

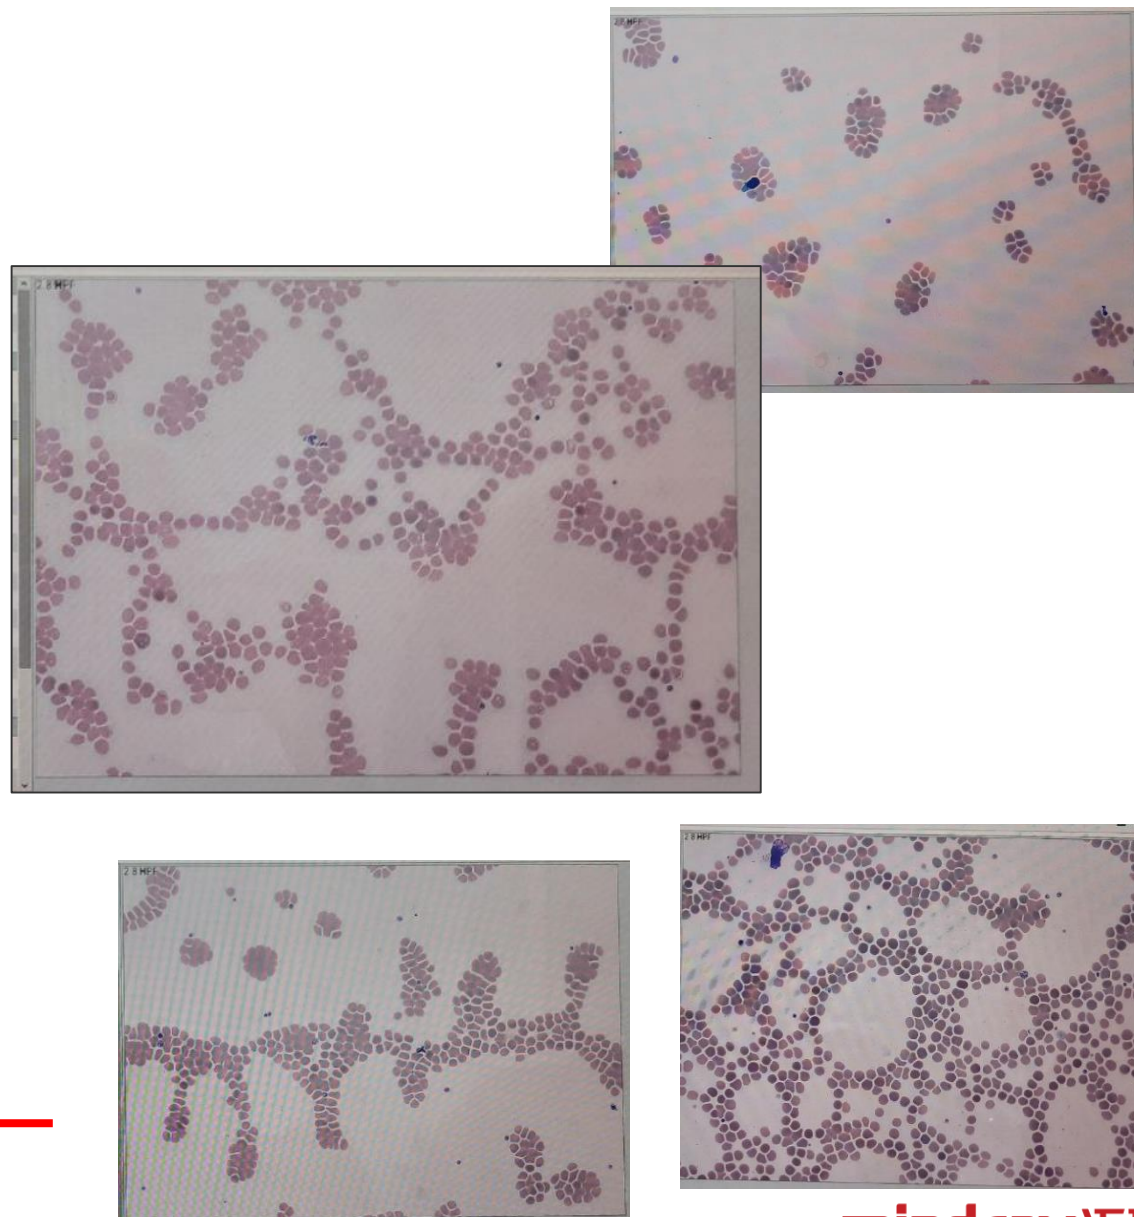
Smear's pictures was made at **wrong working area**

30% of smears.

For laboratory with this workflow it's large amount of wrong smears.

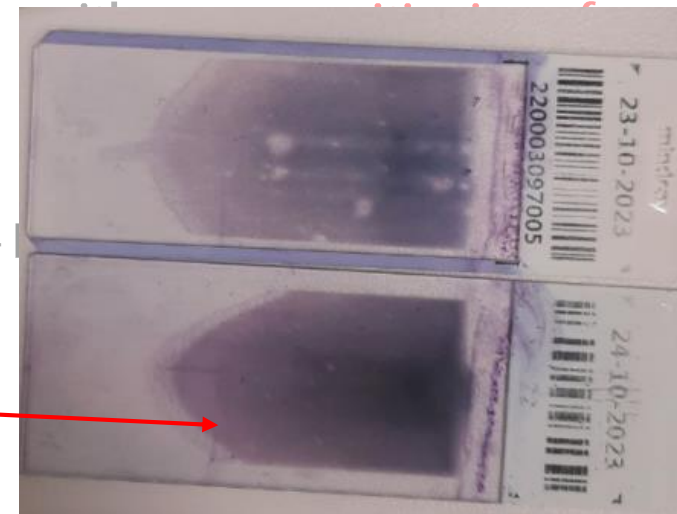
Possible reasons at MC-80 could be related
tail of smears shifted to the left; working area:

adjusted;
on needed

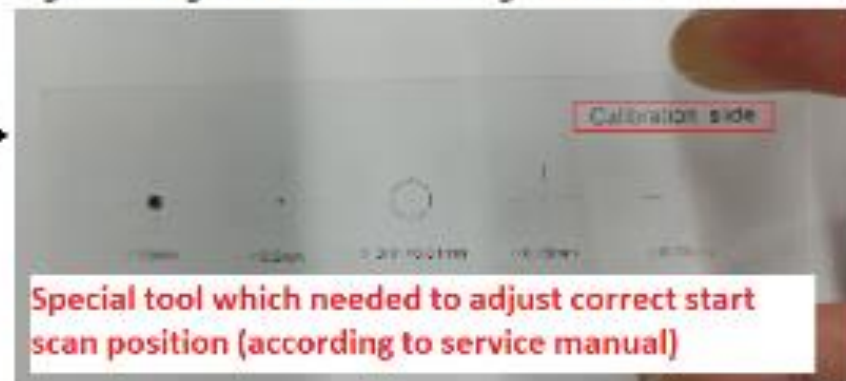
Figure 2 Diagram of Fixture Placing Direction

2. **Scan start position wasn't adjusted correctly.** After communications with engineers was found for correct scan start position adjustment they need special tool - calibration slide but it not included in the set.

3. We **started to adjust scan start position** manually (without this special tool) and **increased brightness** more than 40
