# Gangrenous Appendicitis in a Pediatric Patient.

## Case Report

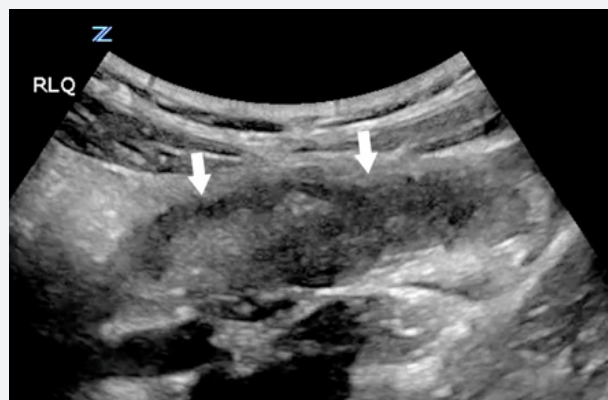
**Figure 1a.** Large inflamed appendix filled with heterogeneous fluid (arrows).

Sagittal section through the lower abdomen revealed a large, dilated, thick-walled appendix filled with heterogenous fluid. (Figure 1) Small punctate echogenic foci were noted within representing microbubbles that are common in emphysematous inflammatory states. (Figure 2) Additional sonographic findings included a large calculus within the appendiceal lumen (appendicolith) and a small amount of complex free fluid in the periappendiceal space. (Figures 3 and 4) All of these sonographic findings were consistent with acute ruptured appendicitis and the patient was urgently transported to the surgical suite. Operative examination confirmed the diagnosis of gangrenous appendicitis with microperforations. The diseased appendix was removed and the postoperative course was unremarkable. Had the child been released from the ED based on the results of the initial ultrasound examination, catastrophic sequelae surely would have ensued.

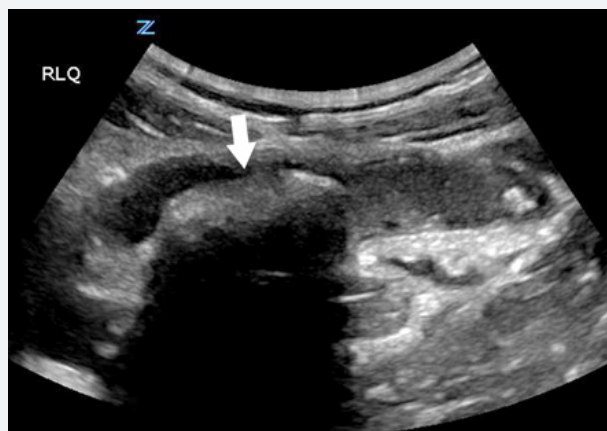
**Figure 3.** Large calcified appendicolith (arrow) in a large, inflamed appendix.
