## Case Study

# The Efficacy of Three-Dimensional Ultrasound Imaging In Identifying Intrauterine Contraceptive Device Malposition

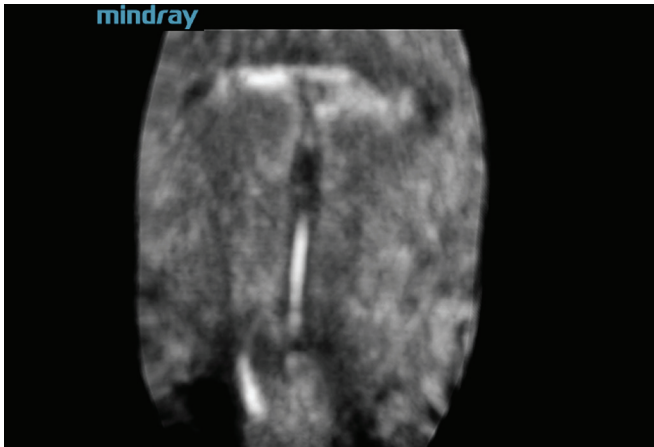
Figure 7 - 3D reconstructed image demonstrating IUCD in normal location within the uterine cavity.
